Is This a Fall Hazard?

Photos in this presentation are from the OSHA Region 4 National Photo Archive and OSHA Region 5.

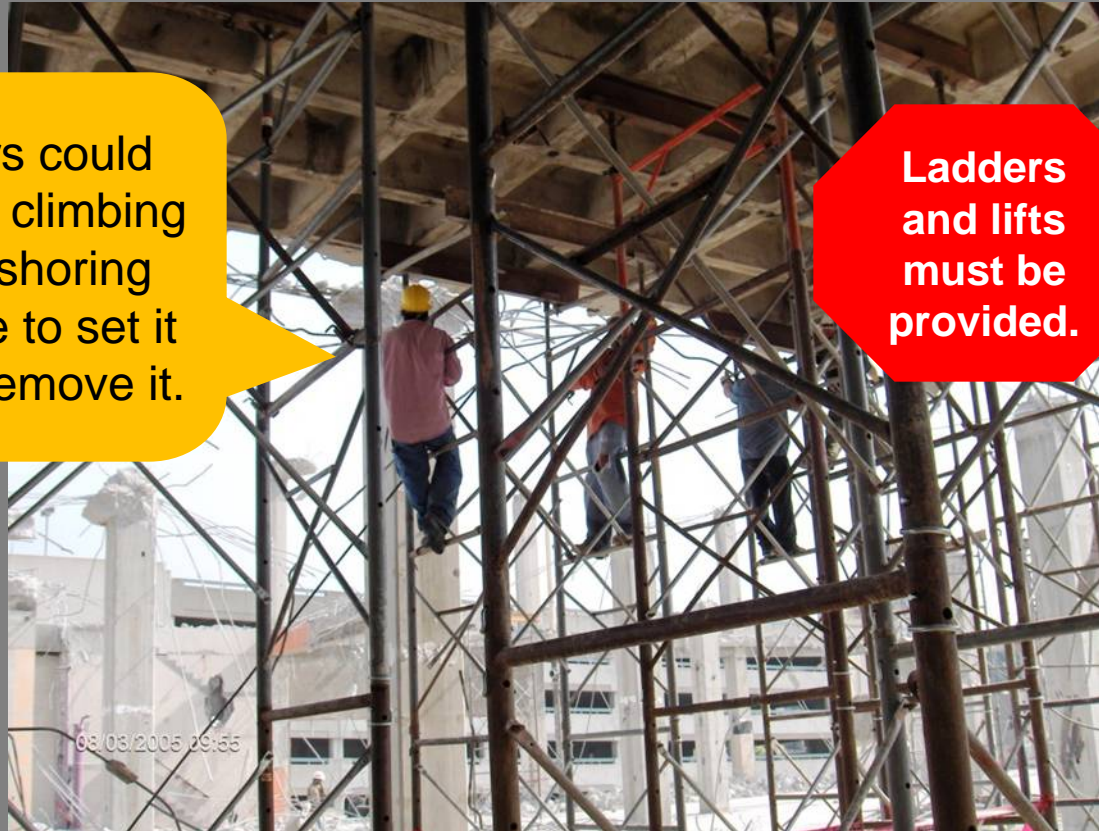
Workers could fall while climbing on the shoring structure to set it up and remove it.

Ladders and lifts must be provided.

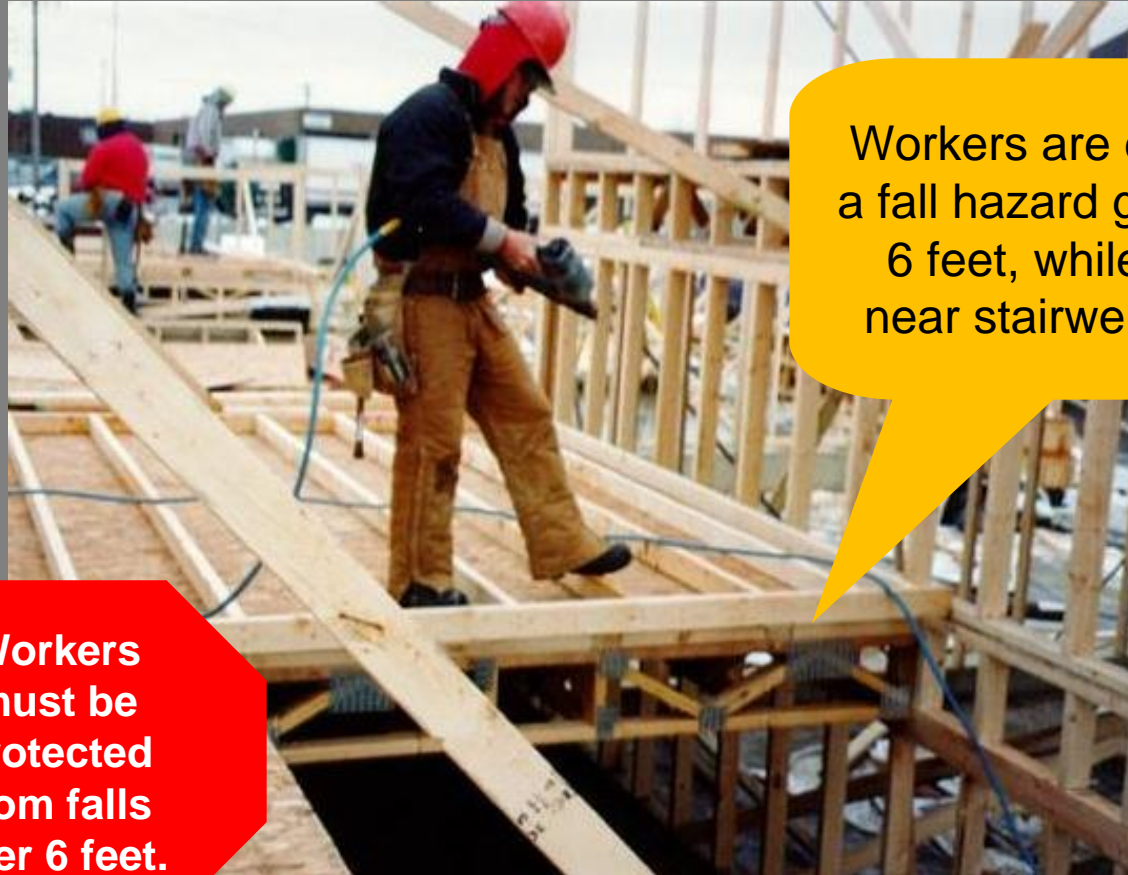
Workers are exposed to a fall hazard greater than 6 feet, while working near stairwell opening.

Workers must be protected from falls over 6 feet.

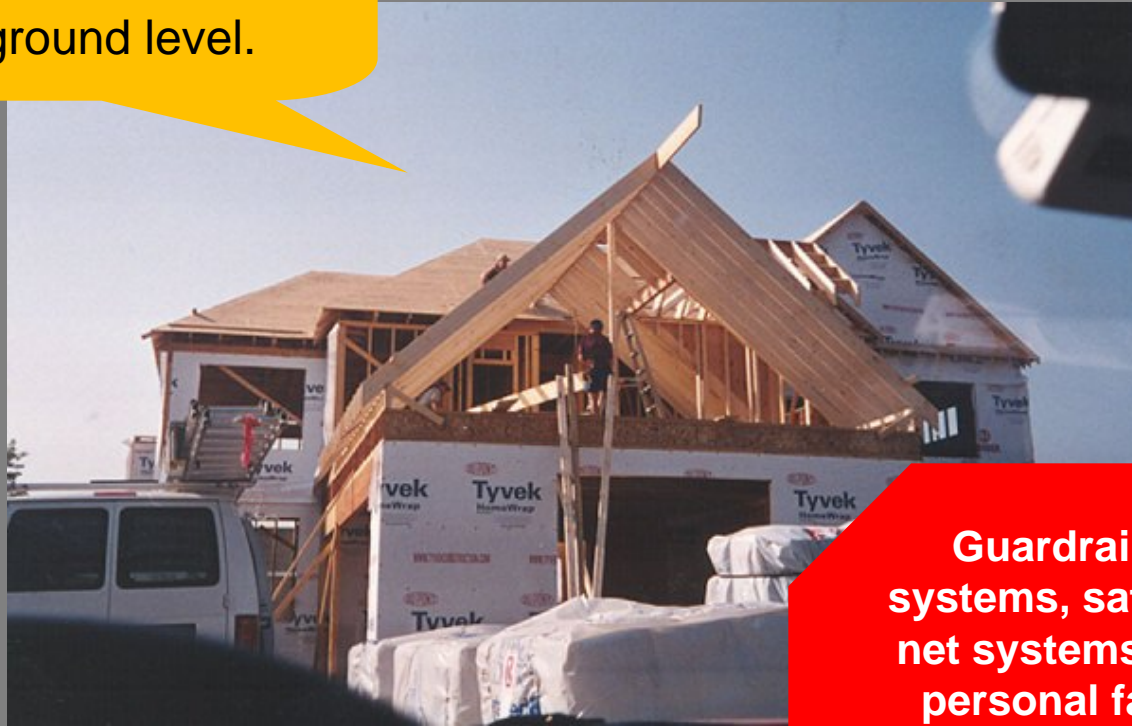
Unprotected open-sided floors 6 feet or more above ground level.

Guardrail systems, safety net systems or personal fall arrest systems are required.

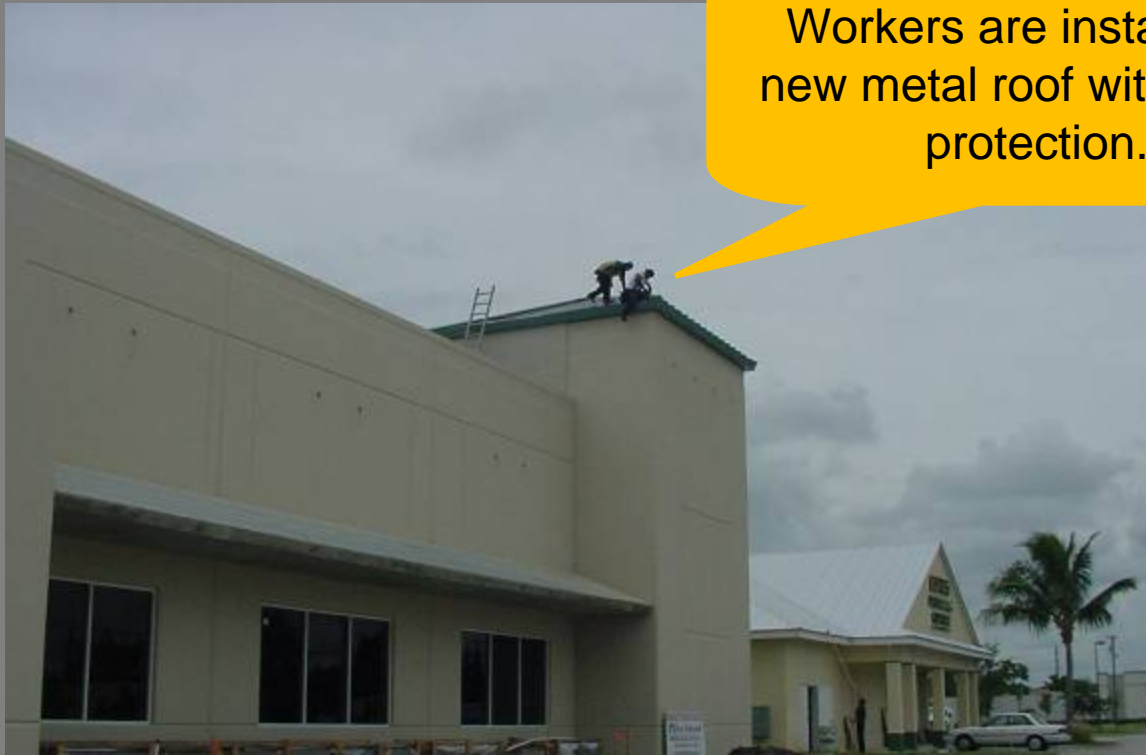
Workers are installing a new metal roof without fall protection.

NOTE: Remember that ladders must extend 3 feet above the landing area.

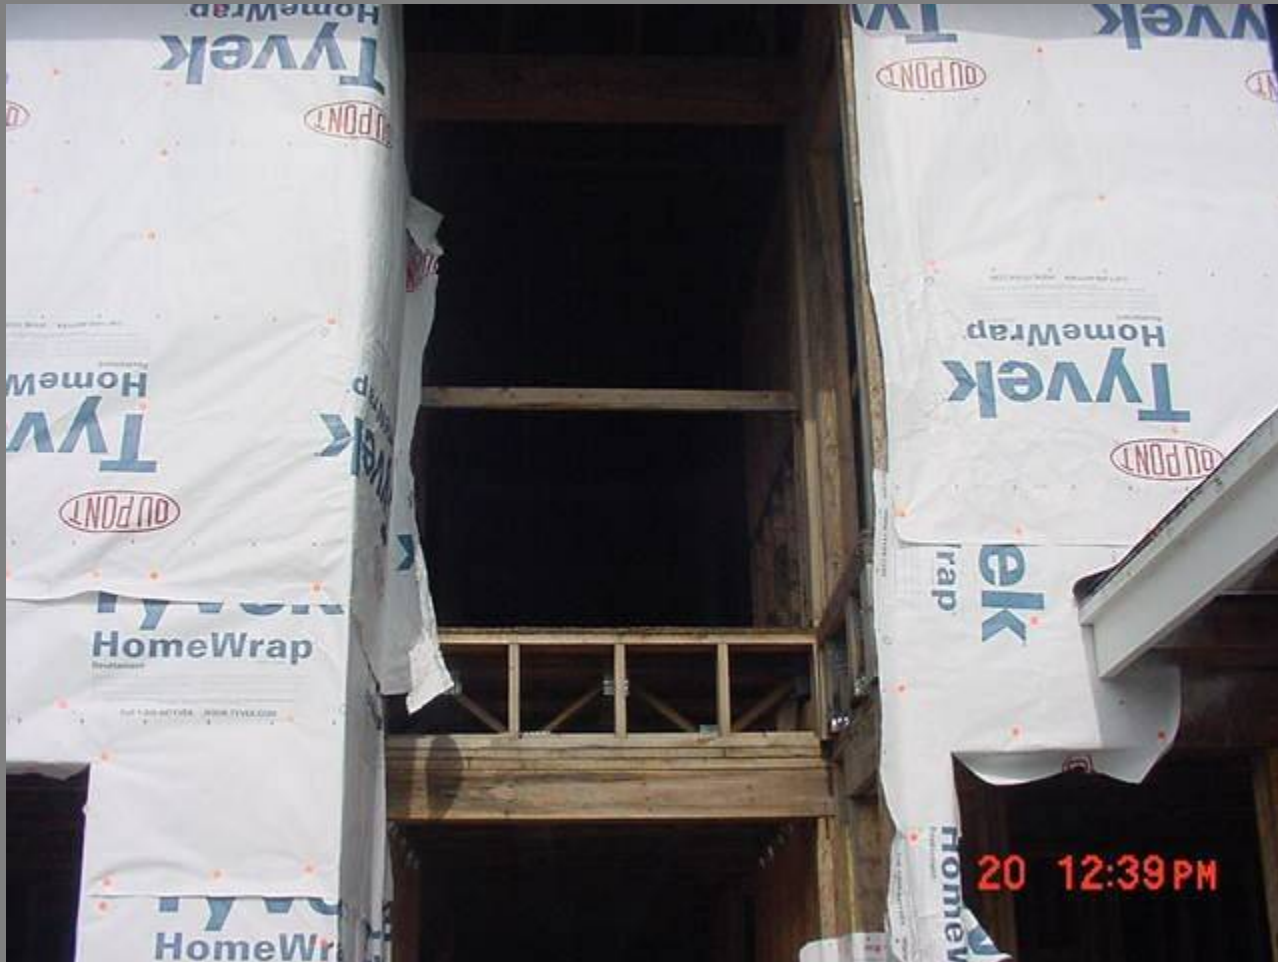
The photo shows a mid-rail and toeboard are missing on an open-sided floor of a building.

This could expose workers to a 12 foot fall.

Toeboards are required to protect workers below from falling objects.

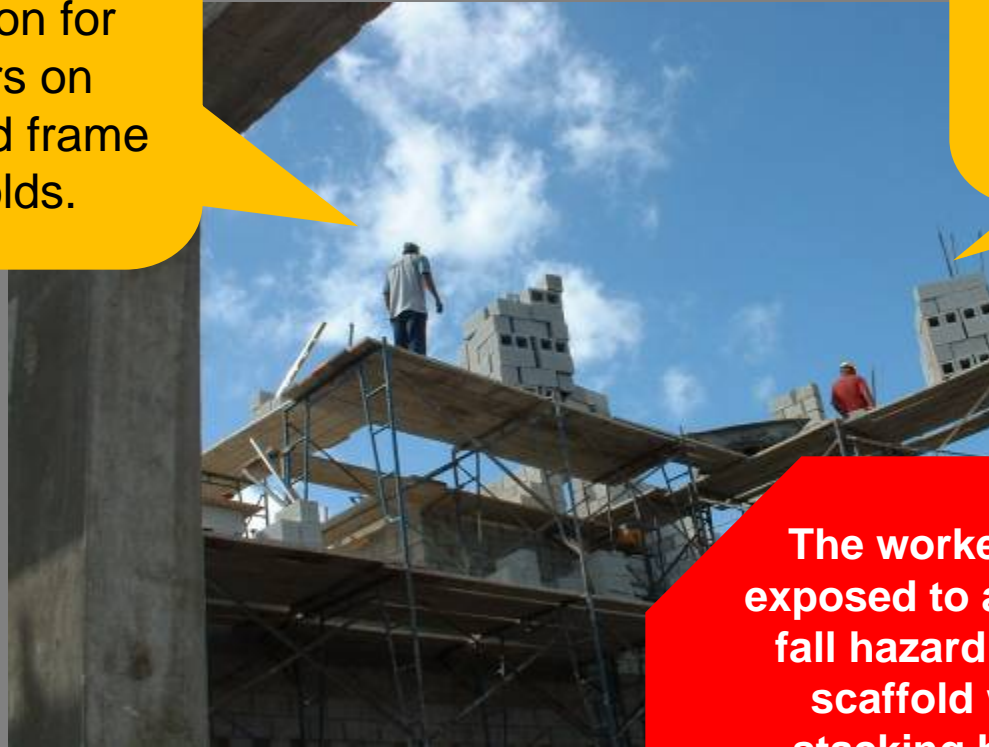
Lack of fall protection for workers on fabricated frame scaffolds.

Planks appear to be overloaded and there is no safe access for workers.

The workers are exposed to a 35-foot fall hazard from a scaffold while stacking blocks prior to overhand bricklaying operations.

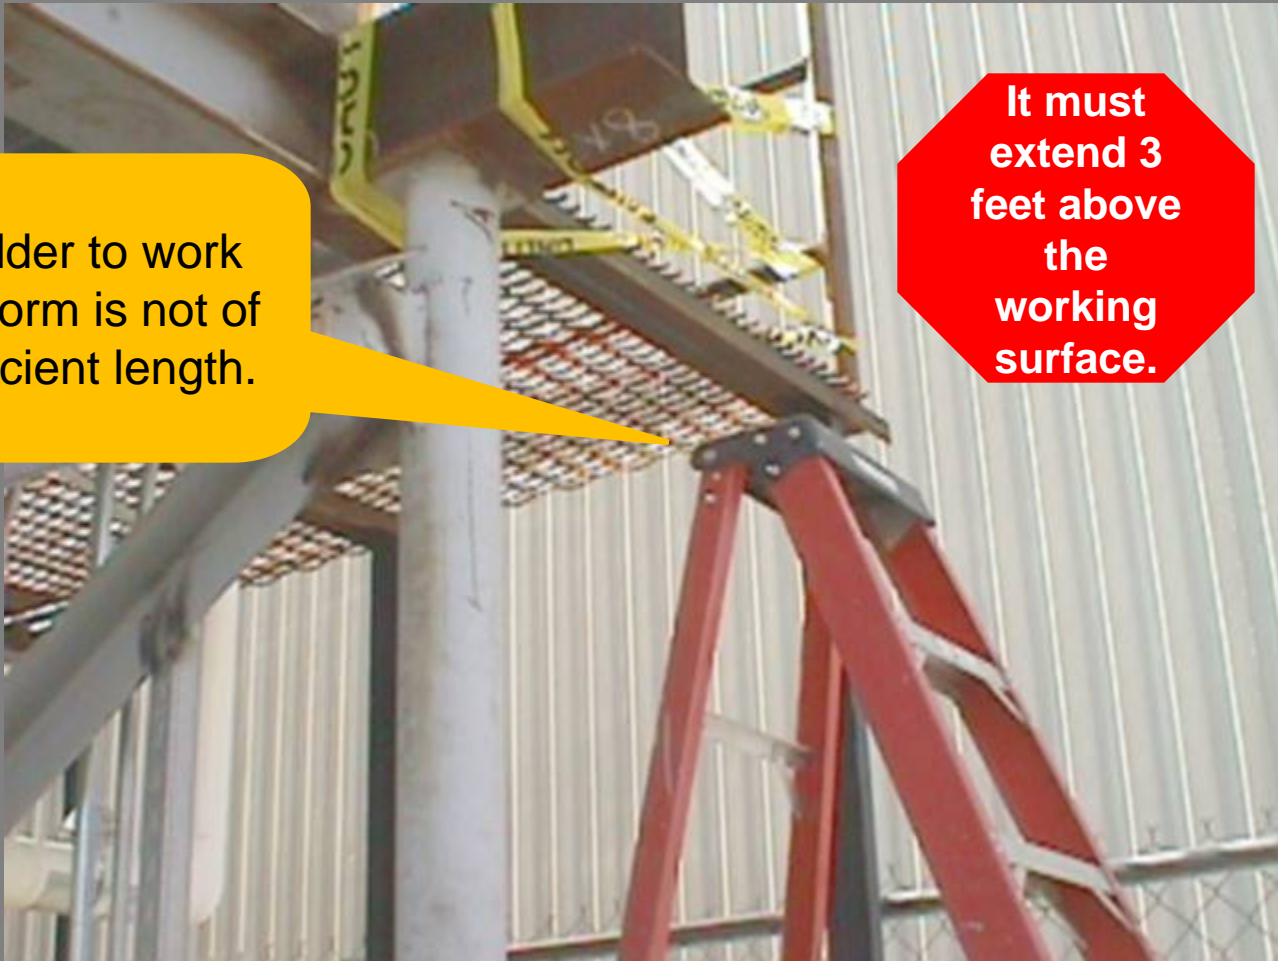
Ladder to work platform is not of sufficient length.

It must extend 3 feet above the working surface.

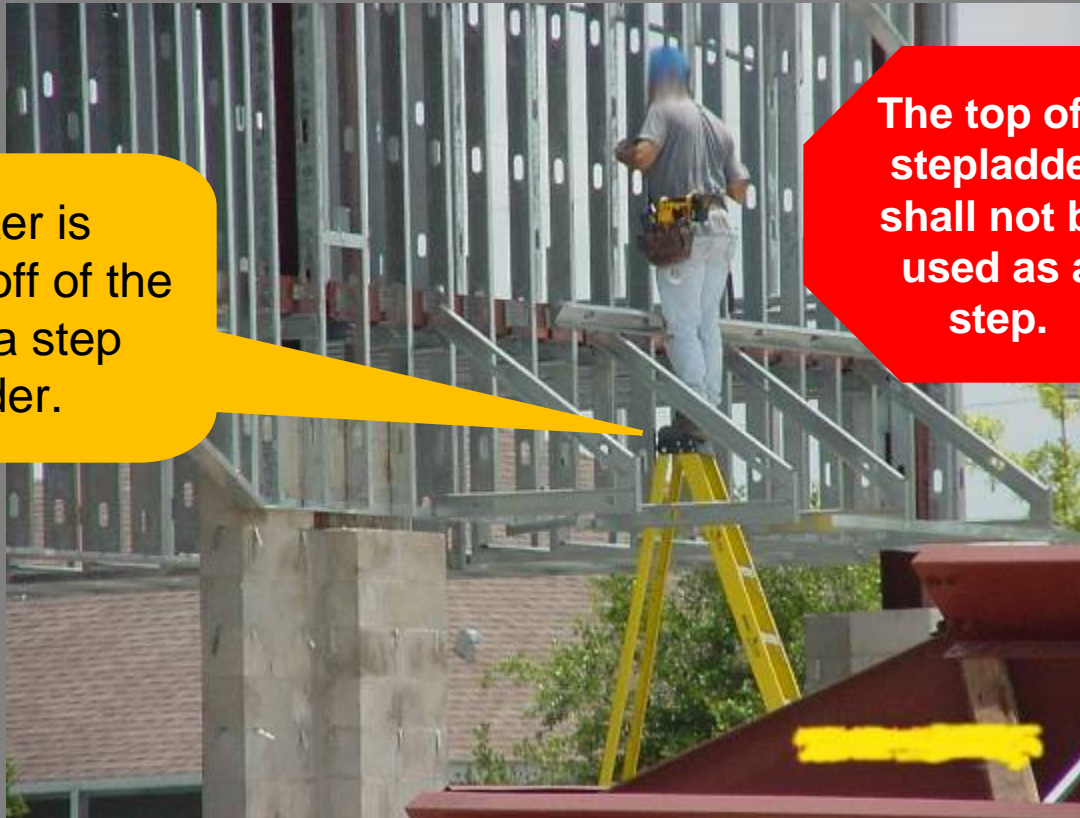
Worker is working off of the top of a step ladder.

The top of a stepladder shall not be used as a step.

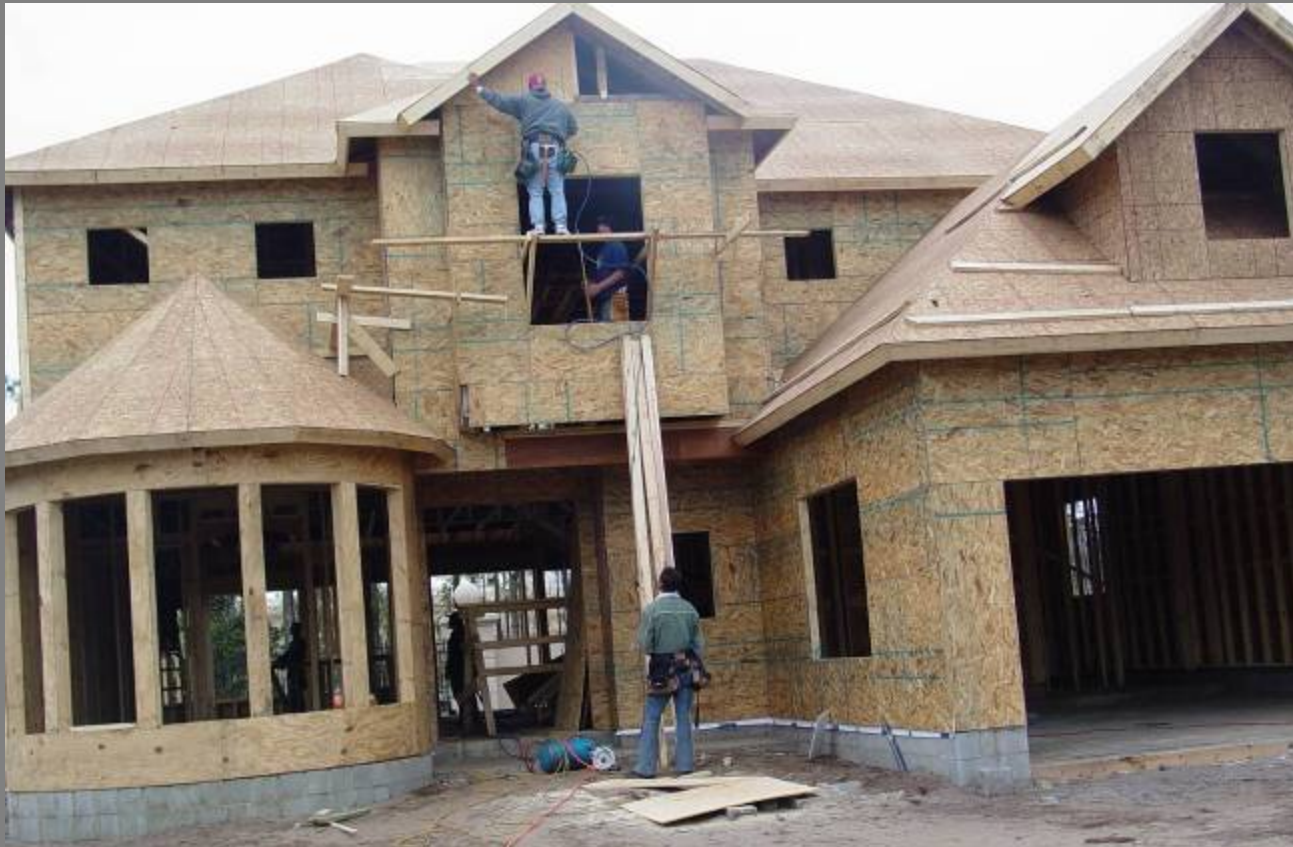
A worker is working from a carpenter's scaffold that has no guardrail, extends too far beyond either end, and is not wide enough.

The worker inside of the window is not provided with fall protection as there is no standard guardrail for the window.

The worker also does not have proper access to the scaffold.

The worker working below is exposed to the struck-by hazards of tools and equipment falling from the employees working above.

NOTE: A competent person must supervise as scaffolds are erected, moved and taken apart.

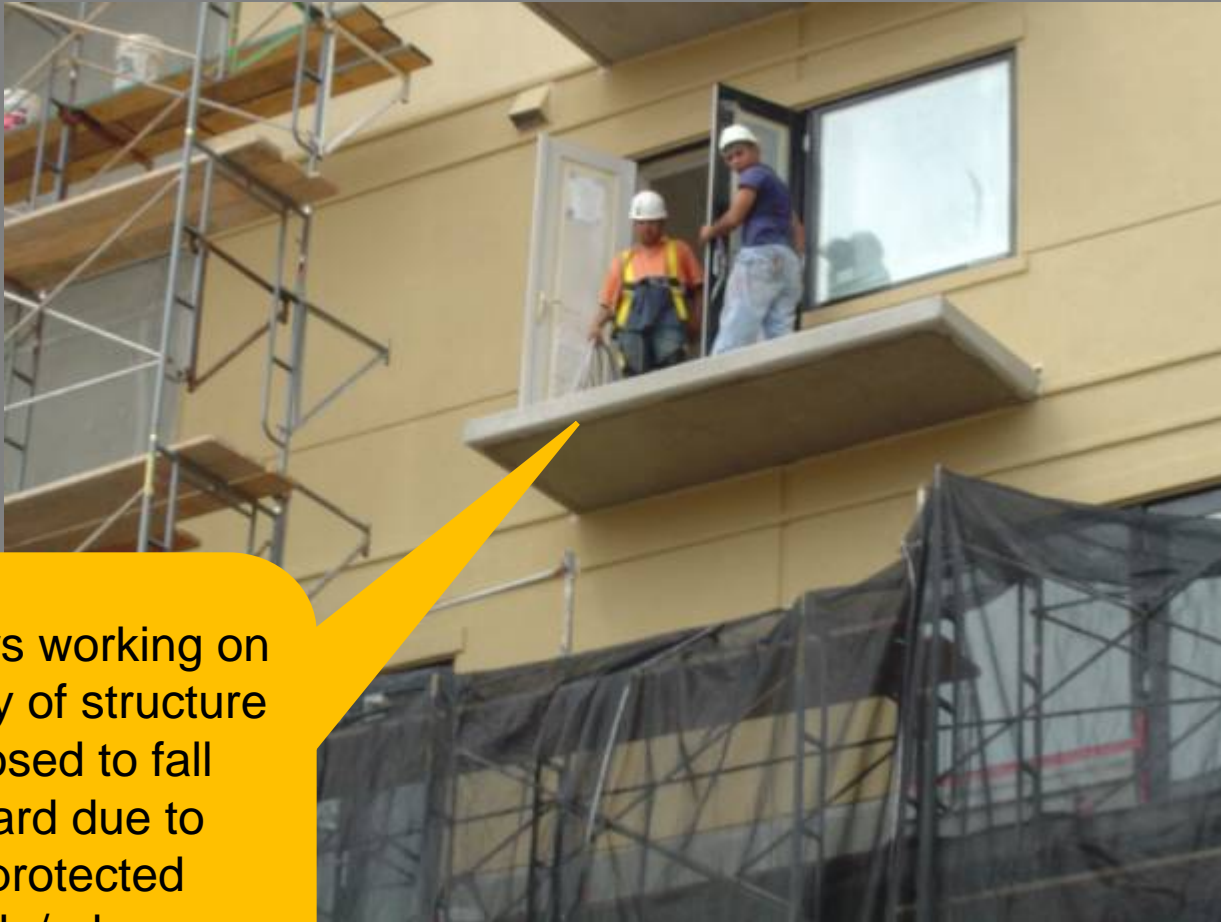
Workers working on balcony of structure exposed to fall hazard due to unprotected side/edge.

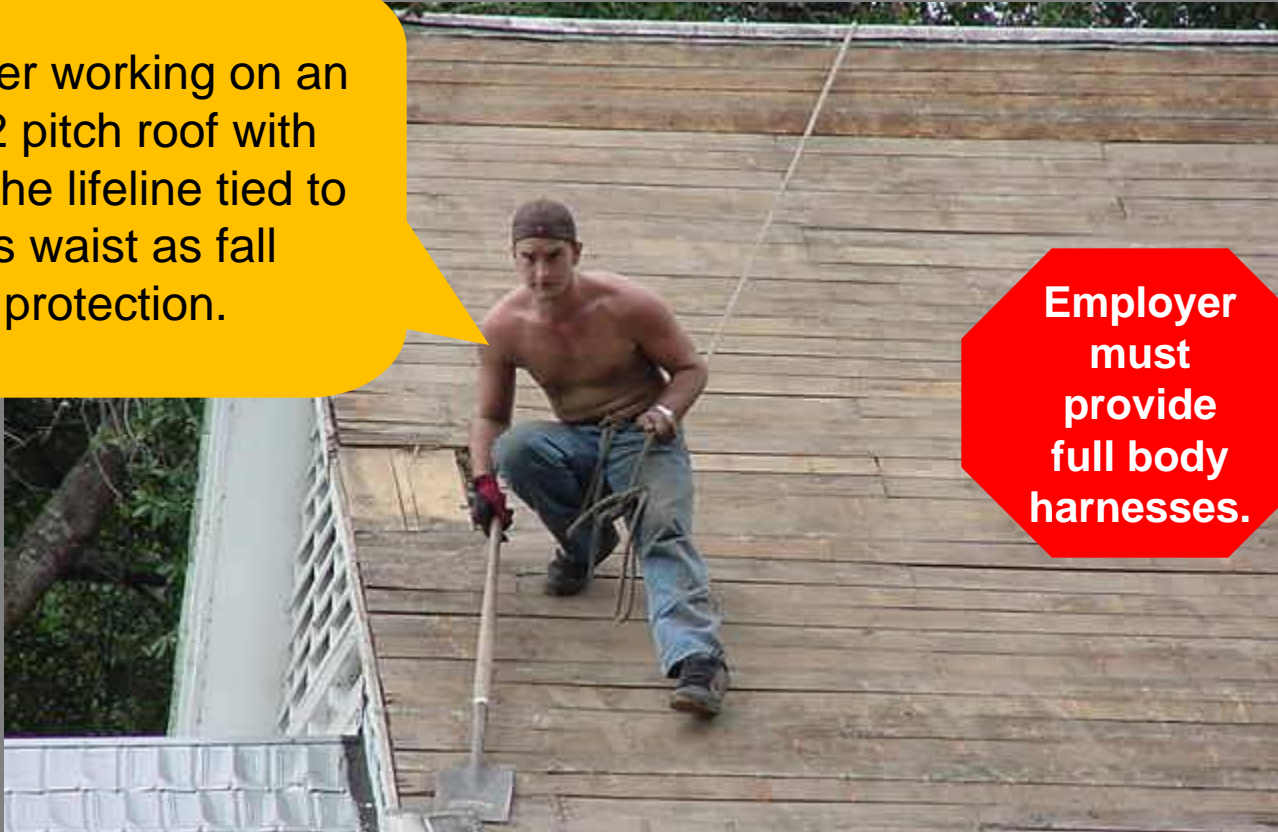
Worker working on an 8:12 pitch roof with only the lifeline tied to his waist as fall protection.

Employer must provide full body harnesses.

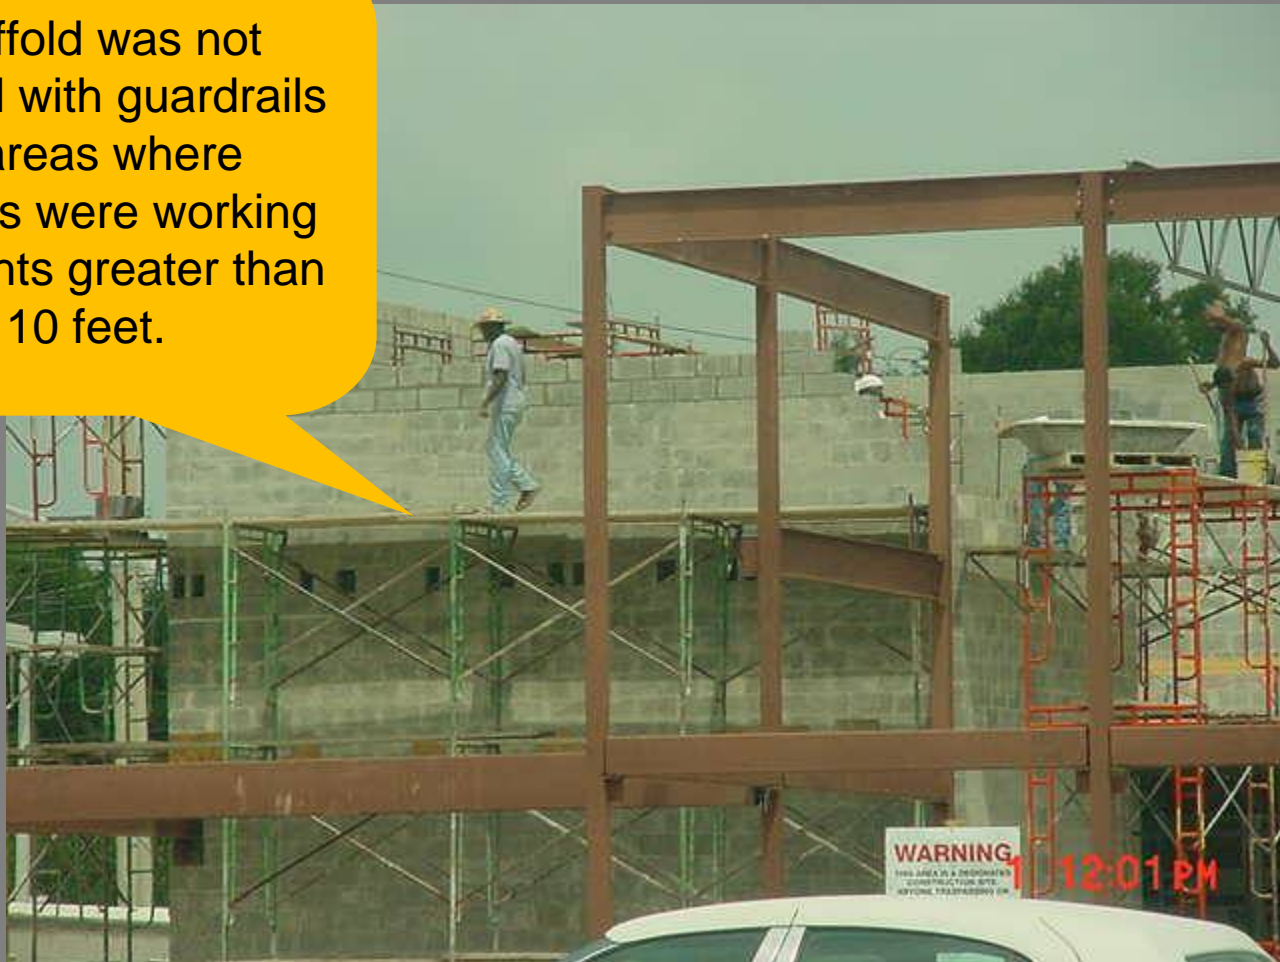
Scaffold was not erected with guardrails in areas where workers were working at heights greater than 10 feet.
